Technical Evaluation of the Gold King Mine Incident

San Juan County, Colorado

U.S. Department of the Interior
Bureau of Reclamation
Technical Service Center
Denver, Colorado

October 2015

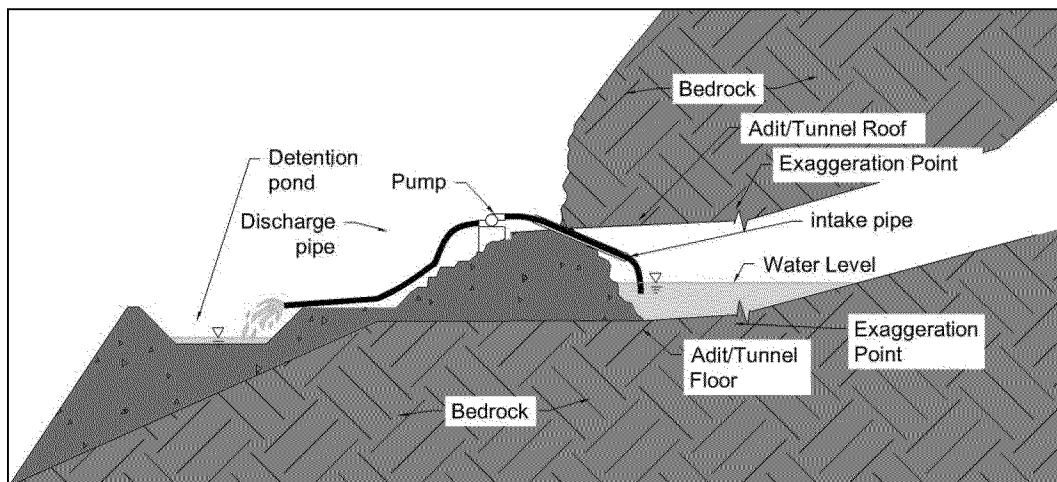
Figure 44.—Cross-section illustration showing step 4 of the plan (not to scale). An intake hose from a pump is inserted into the steel pipe. The pump discharge is taken to a small pond constructed on the waste rock dump. Water from the adit is pumped down. Not shown on this illustration is that the water in the small pond would be continuously removed by another pump and sent to treatment elsewhere on the site.
